Ponce's Landing Inspection

Long Island, Maine

November 29, 2022
Project 2203222

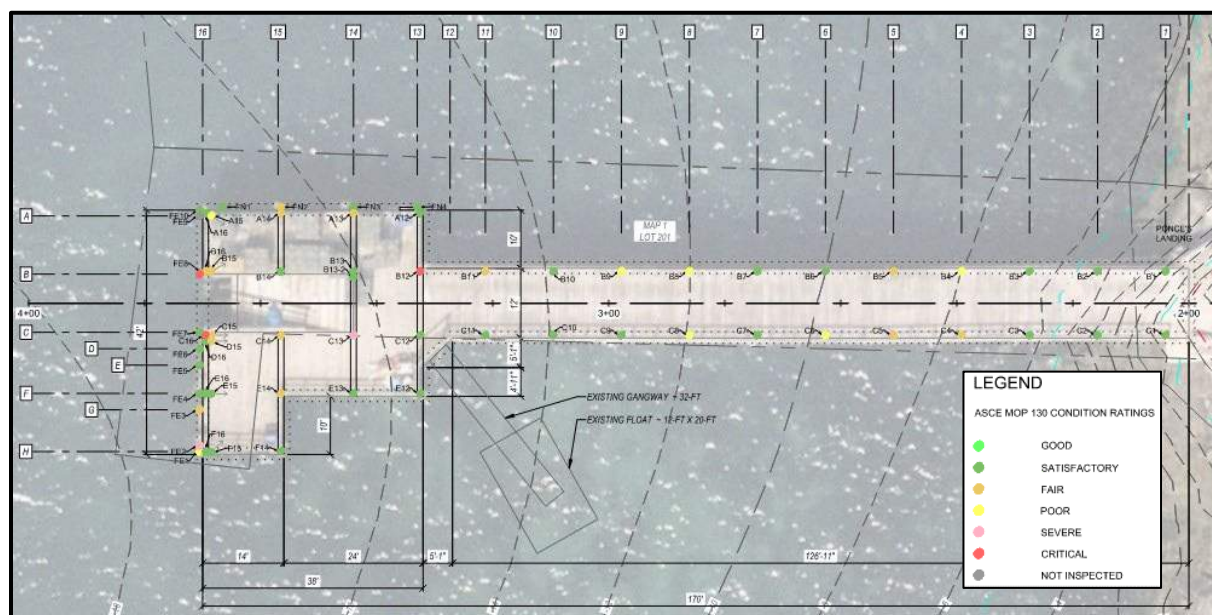
Fig. 4 – Pile Condition Plan

There are a total of 62 existing piles which include 48 timber support piles beneath the pier and 14 fender piles around the pier head. The piles vary in age, condition, and material indicative of a history of intermittent repairs. Piles are in Poor condition with conditions ranging from *satisfactory* (B) to *critical* (F). A summary of pile condition ratings is provided in Table 4 below. Full ratings for all piles are provided in Appendix A. Pile Conditions are depicted in Fig. 4 which is also included in Appendix B. In total twelve (12) piles were given condition ratings of *poor* (D) or worse and are recommended to be replaced.

1. Piles:
 - a. Any piles that rated *poor (D)* or worse should be replaced in-kind. In total, twelve piles have been identified for replacement.
2. Bracing:

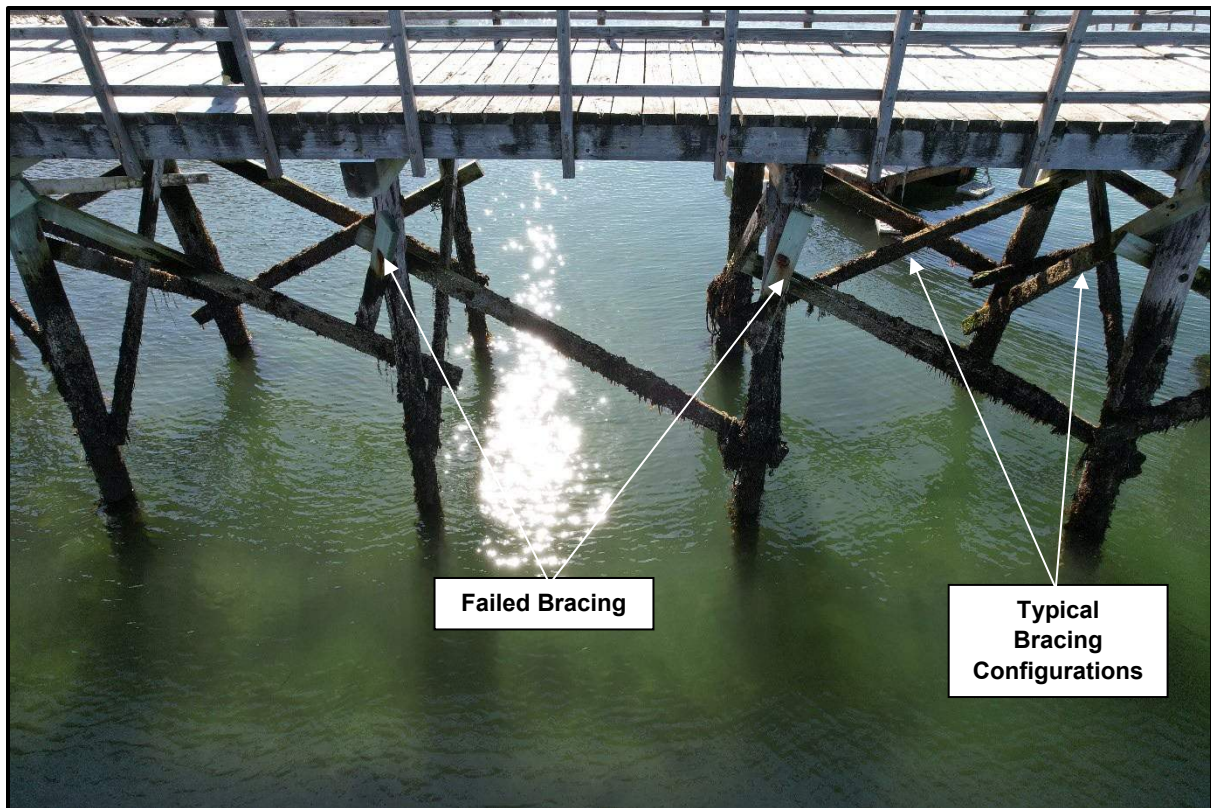
Fig. 5 – Bracing Conditions

Diagonal bracing is installed between piles and bents in both longitudinal and transverse directions. The bracing varies in size including 3x8, 3x10, and 4x10 timber sections. The bracing is generally in *fair* (C) condition, except as noted below.

There are six locations where bracing was missing or broken which were rated *critical (F)* and require replacement. These locations (referenced to pile location) are: B12-C12, B11-B21, FN2-FN3, F14-F15, E13-E14, and C8-C9.

There are several locations where the bracing has been recently replaced as can be observed by the color of the newer timbers and relative lack of marine growth. These are in *satisfactory (B)* condition. Refer to Fig. 5 for typical bracing conditions.

- a. Replace all broken/missing sections of diagonal bracing with new 4x10 timber sections. There are at least 7 locations with broken/missing diagonal bracing.

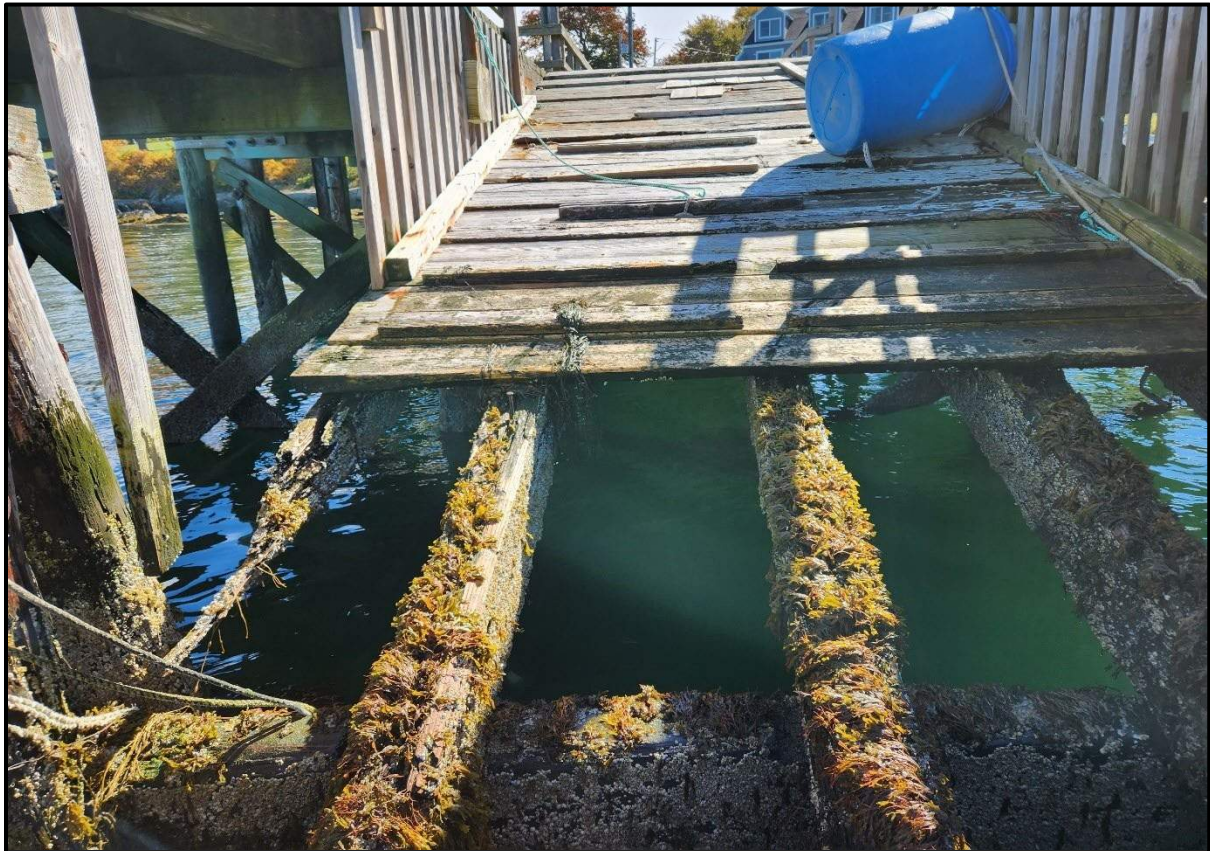
Fig. 6 – Pier Head Loading Ramp Condition

A loading ramp is located at the pier head. The loading ramp transitions the pier deck to a lower elevation (See Fig. 6 below). The entire ramp is severely deteriorated including the stringers – some of which have 100% section loss, decking – some of which is missing entirely, and connection to support piles – which is compromised by the severe section loss of timber framing. This entire area is rated in *critical (F)* condition. It is recommended that use of this area be prohibited and access restricted.

- e. If use of the pier head loading ramp is to be resumed, this area of the pier will require full replacement.
4. Gangway:
 - a. Replace decking at gangway landing location on pier.

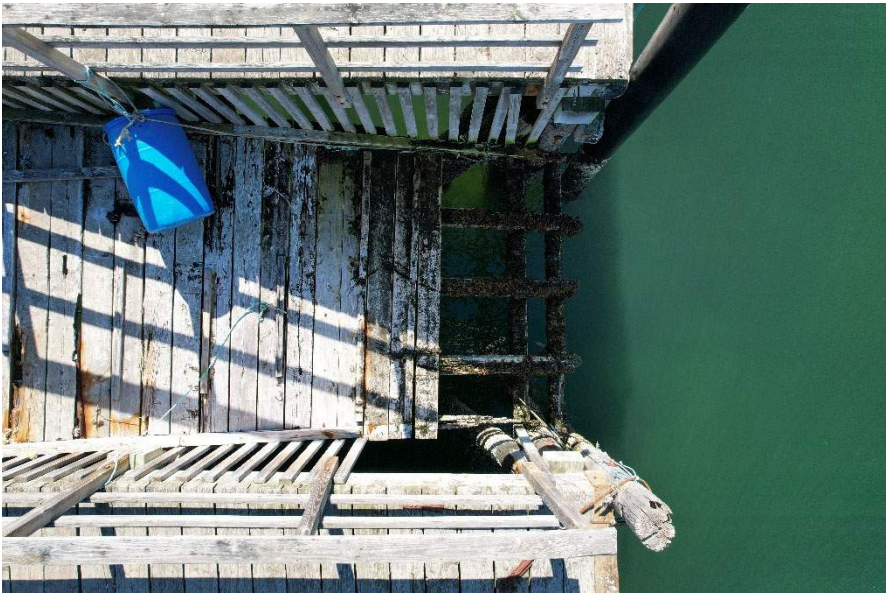
<p>Photo No. 8: Aerial view of damaged loading ramp.</p>

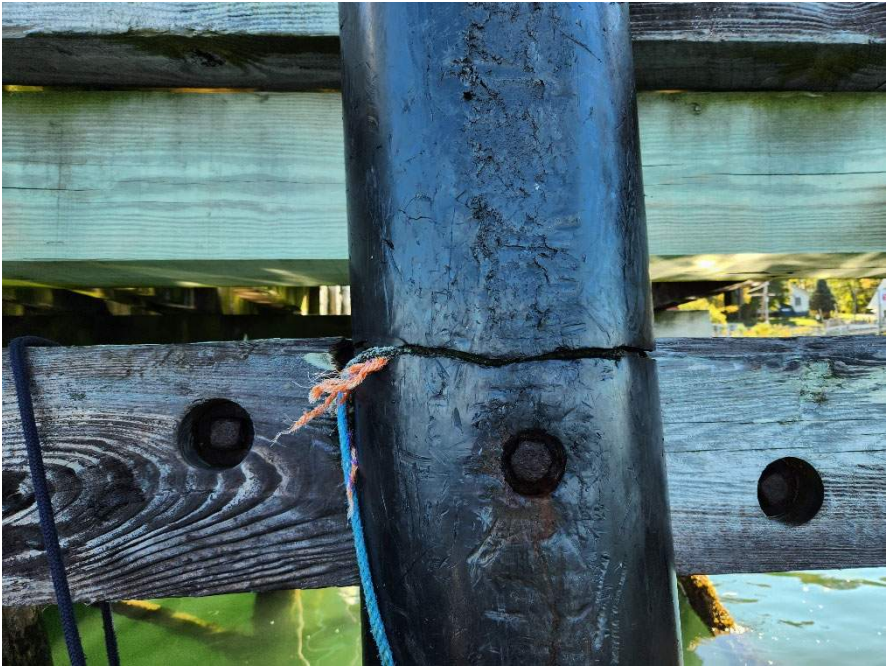
<p>Photo No. 9: Composite pile with horizontal splits.</p>

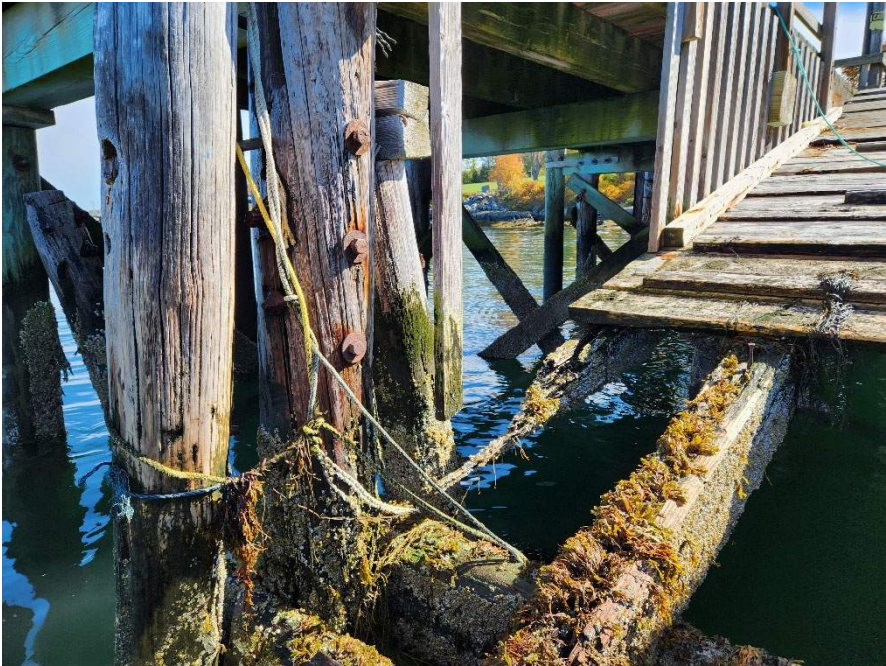
<p>Photo No. 10: Deterioration of loading ramp stringers and planking.</p>

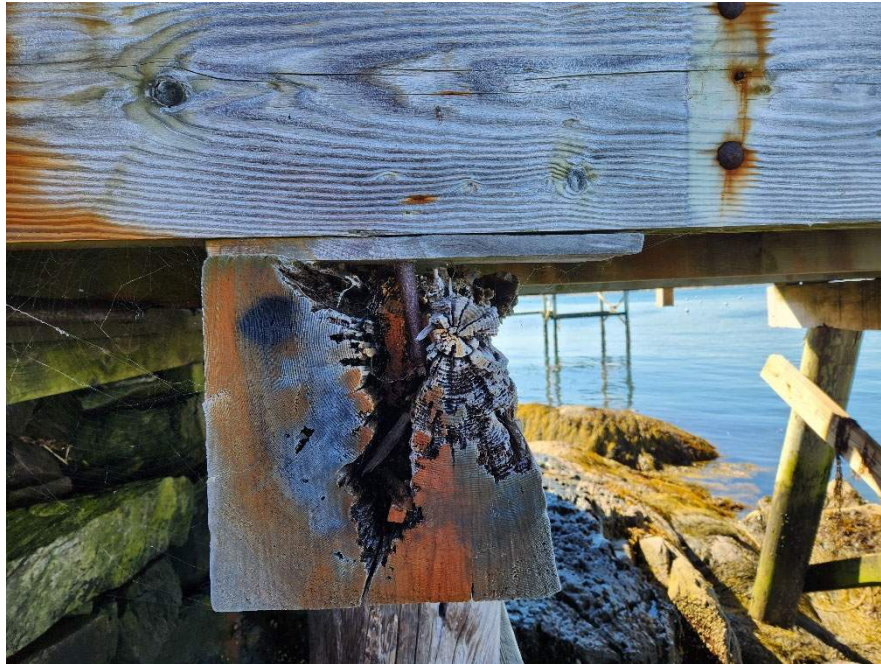
The pile caps consist of 12x12 nominal timber sections. The pile caps are in *fair (C)* condition. Some pile caps have been replaced recently. There are several locations where the pile caps have significant splitting including above pile B5, B11, B14-C14, and C9. See Photo 11 for example.

Photo No. 11: Pile cap in deteriorated condition. There are several pile caps in this poor condition.

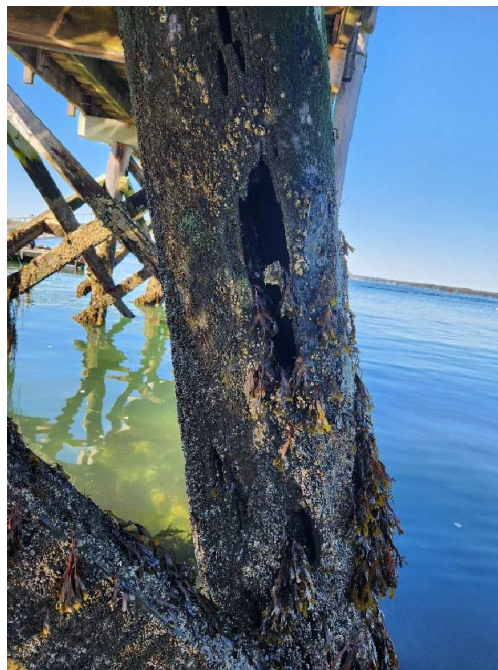
Photo No. 12: Pile with severe checking, splitting, and section loss.

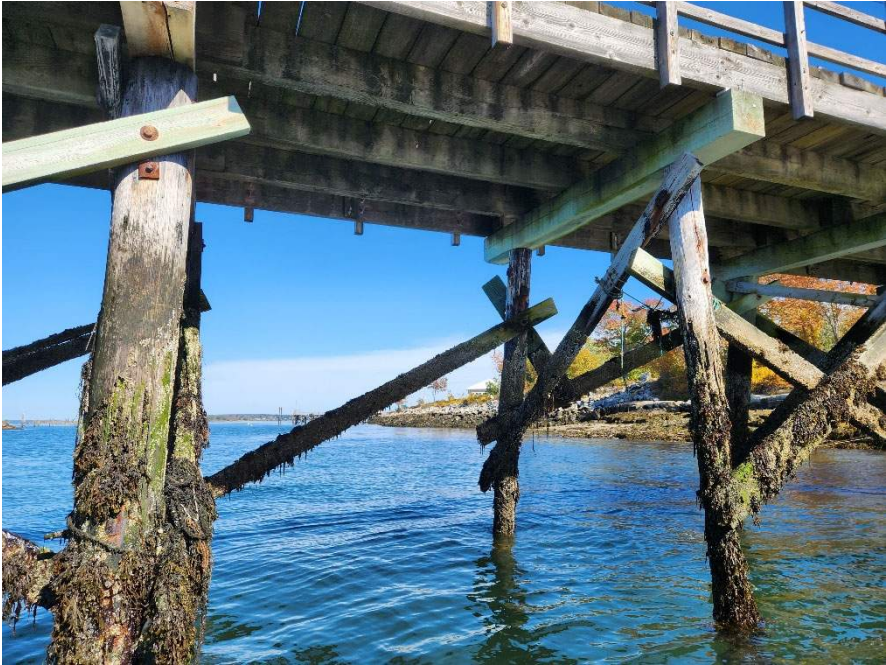
<p>Photo No. 15: Bracing missing in several locations between bents.</p>

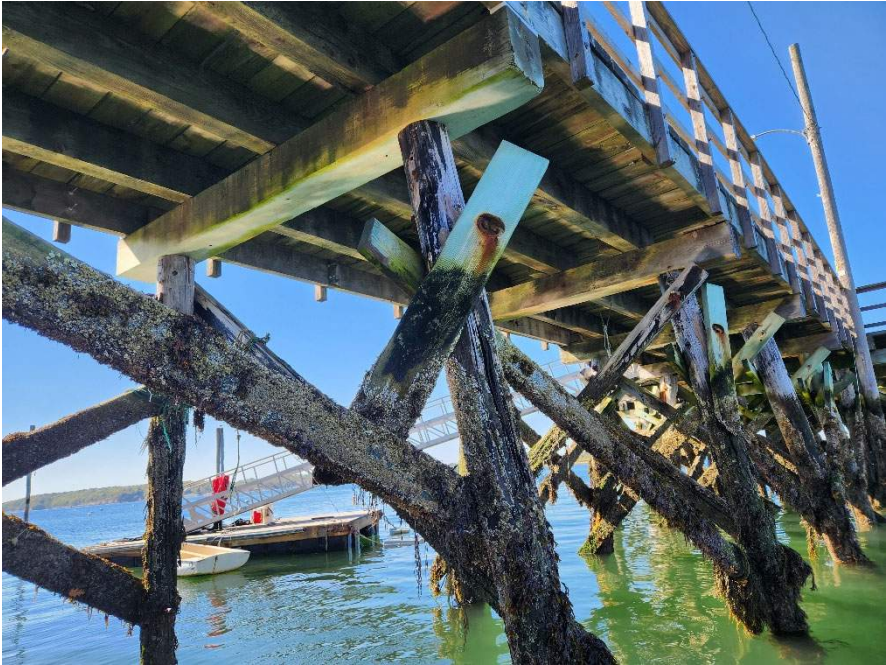
<p>Photo No. 17: Bracing between pile bents that has broken and is hanging.</p>

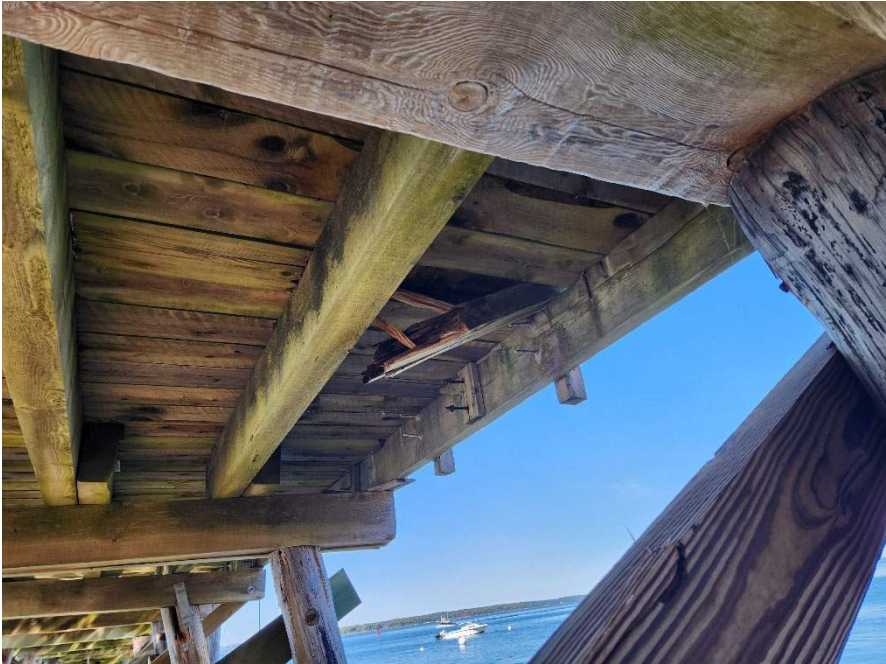
The decking consists of 4x10 timber boards installed transversely across the width of the pier. The decking is generally in *fair (C)* condition. Localized areas of decking were observed where decking has broken or severely rotted and is in *poor (D)* to *severe (E)* condition. Some of these areas have been covered with plywood as an attempted repair. Forty sections of the timber decking are recommended for replacement. Deck boards were also observed with loose fasteners in many locations that are recommended to be refastened.

<p>Photo No. 18: Underside view of decking failure.</p>

3. Pier:
 - a. Replace broken/severely deteriorated deck boards, approximately 40 locations.
 - b. During the deck replacement, it is recommended that the contractor walk the entire pier and identify any loose boards and securely fasten them.

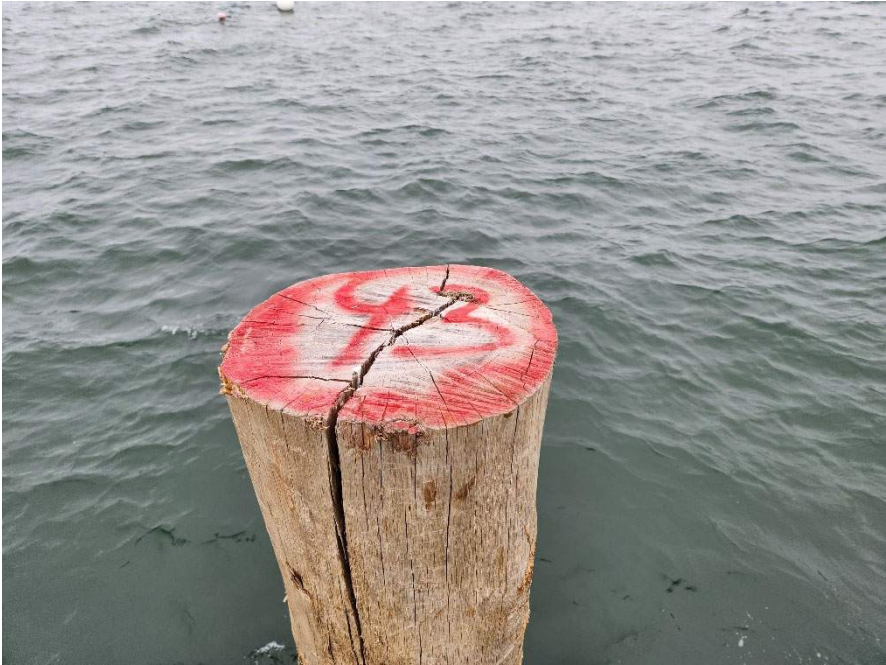
<p>Photo No. 19: Splitting in timber pile.</p>

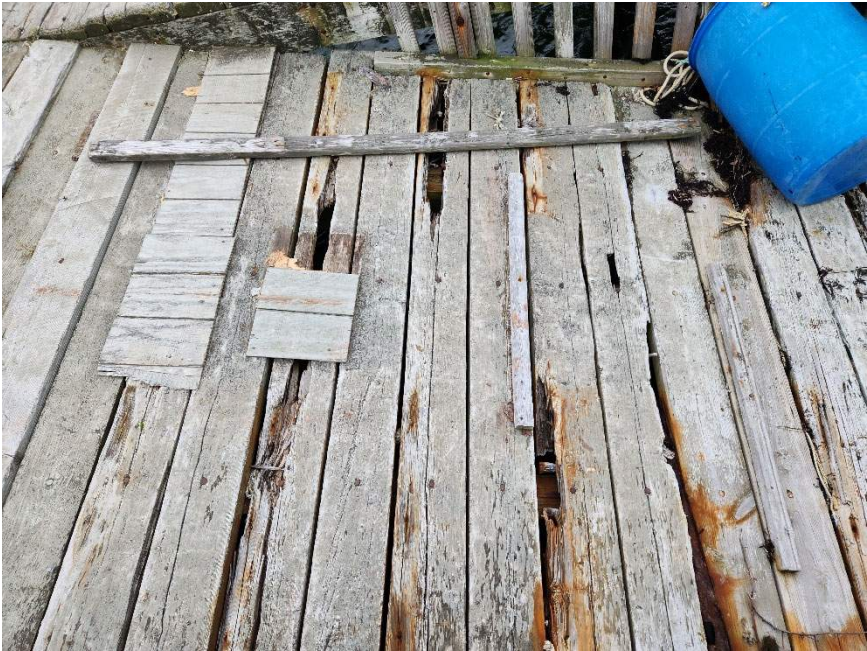
<p>Photo No. 20: Typical conditions of decking on pier. Many locations with patches or significant holes.</p>

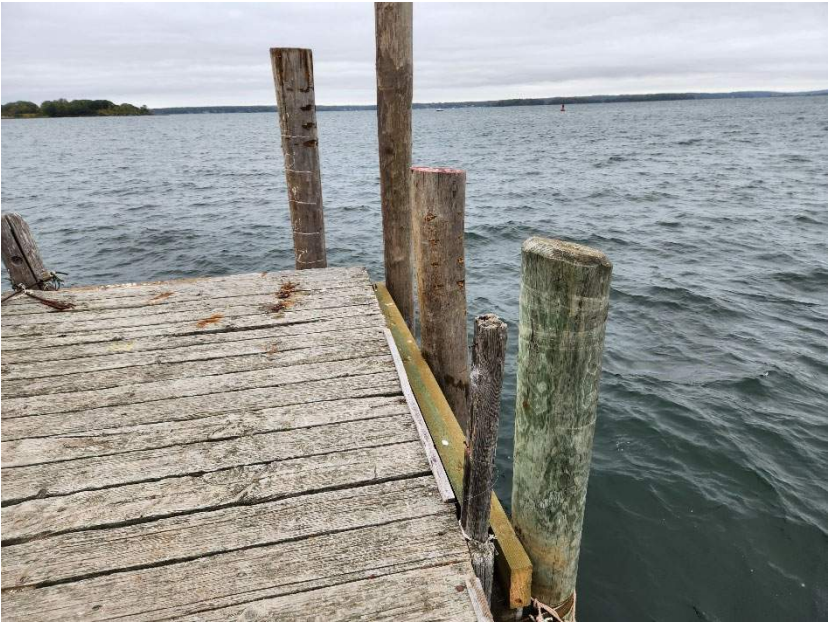
The railings consist of 4x4 posts at approximately 4-foot spacing, with a 2x6 top rail, 2x4 top rail support, 2x4 midrail, and 2x4 low rail. The railings are generally in *fair (C)* condition. Occasional loose connection points were observed. There is no railing present along the west or north face of the pier head.

<p>Photo No. 21: Missing handrail on Northern face of pier head.</p>

- c. Secure loose handrail and replace missing handrail
 - d. If vehicular use is to be resumed on the pier, install code-compliant edge protection including vehicular curbs.

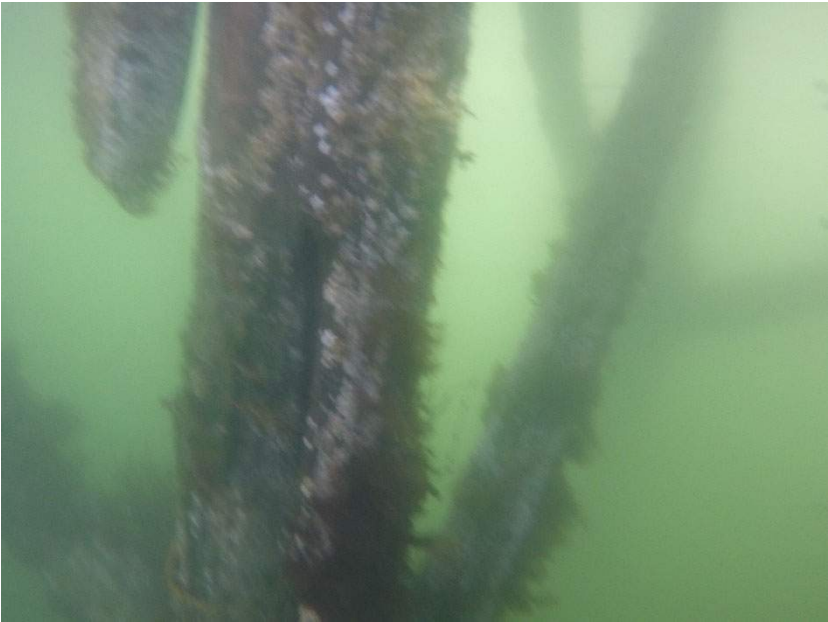
<p>Photo No. 22: Piles showing significant section loss and breakage.</p>

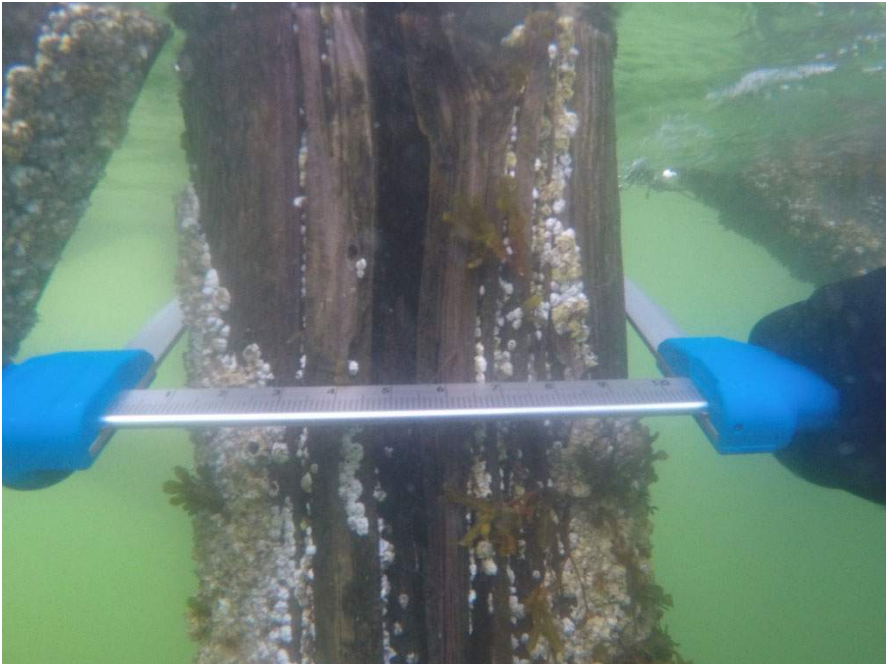
<p>Photo No. 23: Severe splitting of pile.</p>
